PROJECT REPRESENTATIVE'S DAILY REPORT

Pg. 1
Report No. 057
Date: 2014-11-06
Day: Thursday

Project: Renovation and Addition to Tewksbury Town Hall

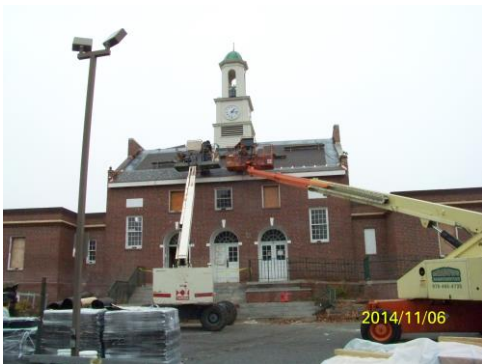
Photo showing roofers working on the east elevation of the main building before the rain started.

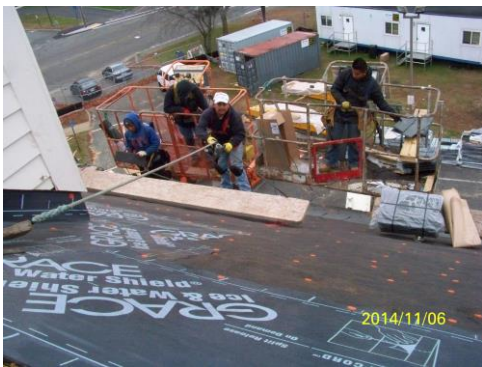
Photo showing the roofers installing the new shingles.

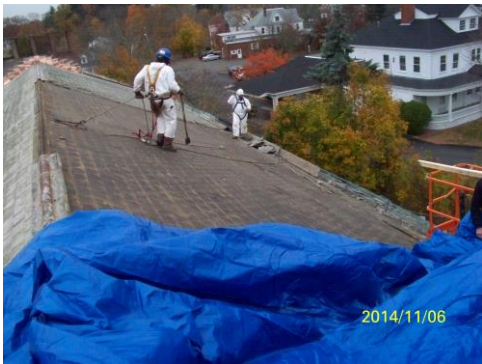
Photo showing the abatement crew working on the north side of the meeting hall roof before the rain started.

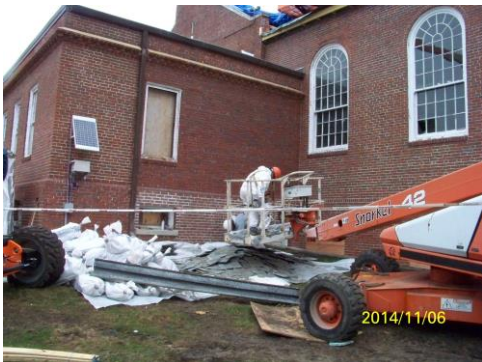
Photo showing abatement crew cleaning up before stopping for the day.

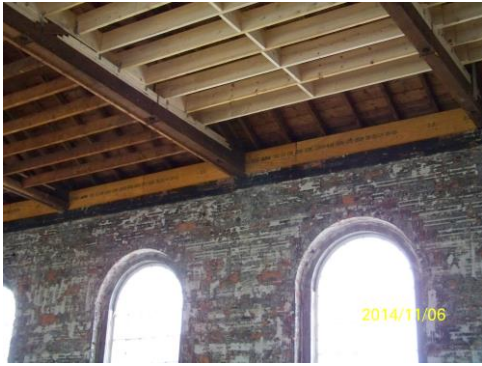
Photo showing the rim joists installed around the meeting hall perimeter.

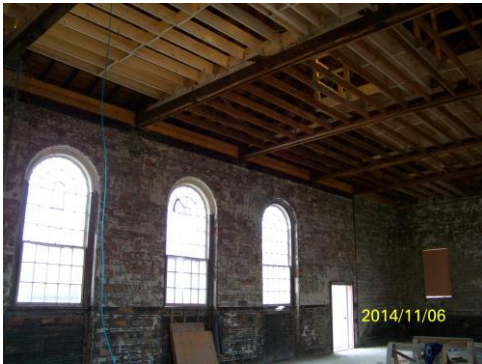
Photo showing additional rim joists around the meeting hall.

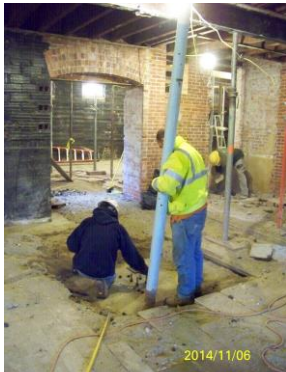
Photo showing the existing posts being installed.

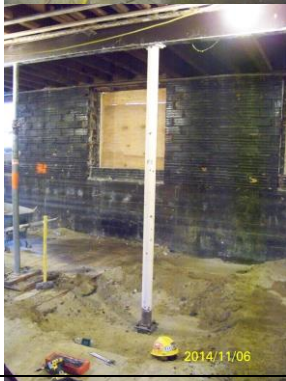
Photo showing an existing post back in place.

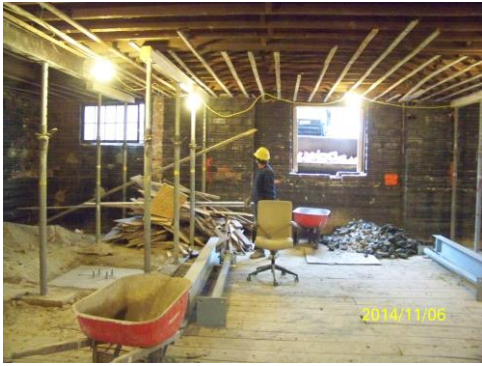
Photo showing laborer collecting debris for disposal.

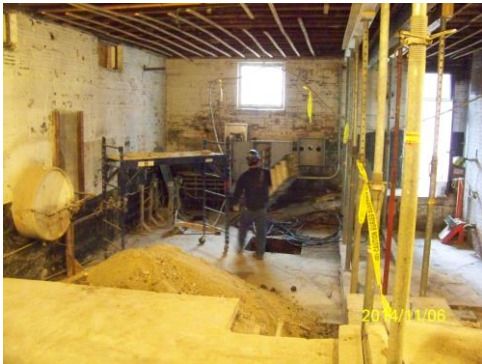
Photo showing electrician working on removing the equipment now that the transformer has been removed.

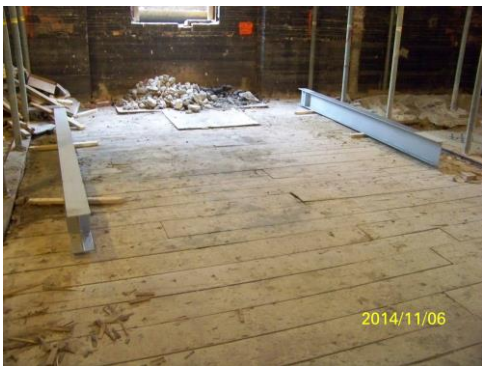
Photo showing some of the new steel on site.
